**Type A Accident
Investigation Board Report
on the February 20, 1996,
Fall Fatality
at the
Radioactive Waste Management Complex
Transuranic Storage Area - Retrieval Enclosure
Idaho National Engineering Laboratory**

March 1996

**Office of Oversight
Environment, Safety and Health
U.S. Department of Energy**

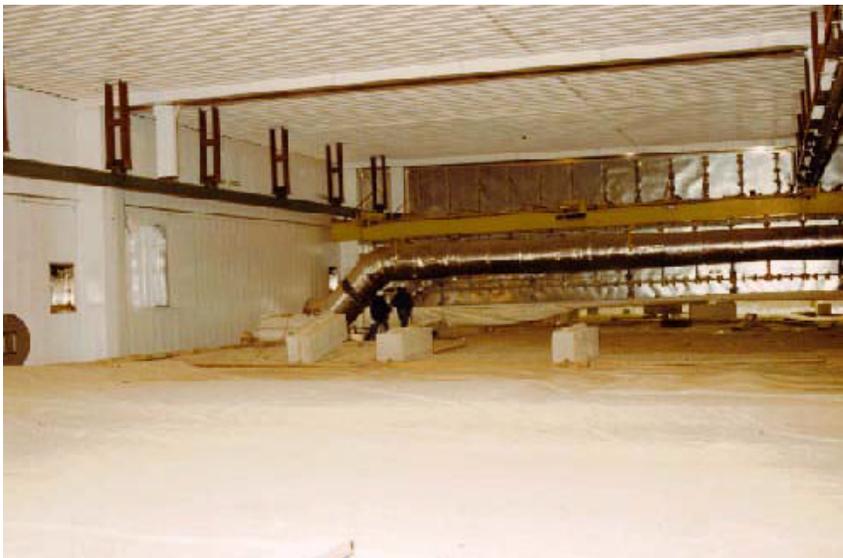
No barriers were installed to keep workers away from the edge of the platform.

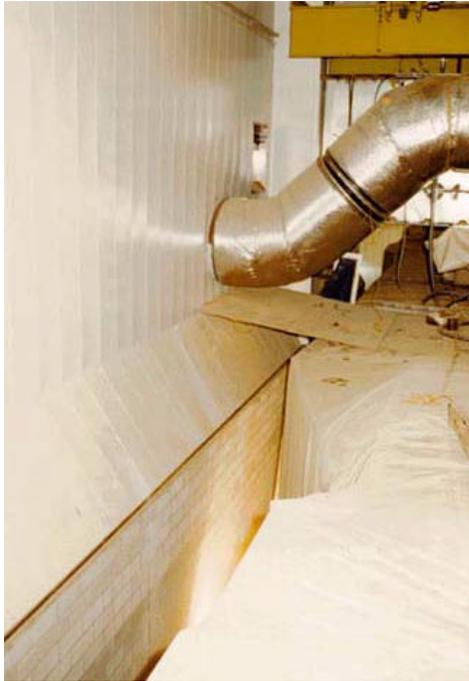
area on top of the box/drum radioactive waste stack on the southeastern portion of the stacked boxes. The area had uneven footing because of the way the boxes and drums were stacked under the fabric. There was a gap approximately 30 inches wide between the edge of the stacked boxes and the adjacent metal and cinder block facility wall. The 4 foot by 4 foot by 8 foot boxes were stacked four high, making the gap about 17 feet deep (see Exhibit 2-2). No barrier was installed to warn workers that they

were within six feet of an unprotected edge of the gap.

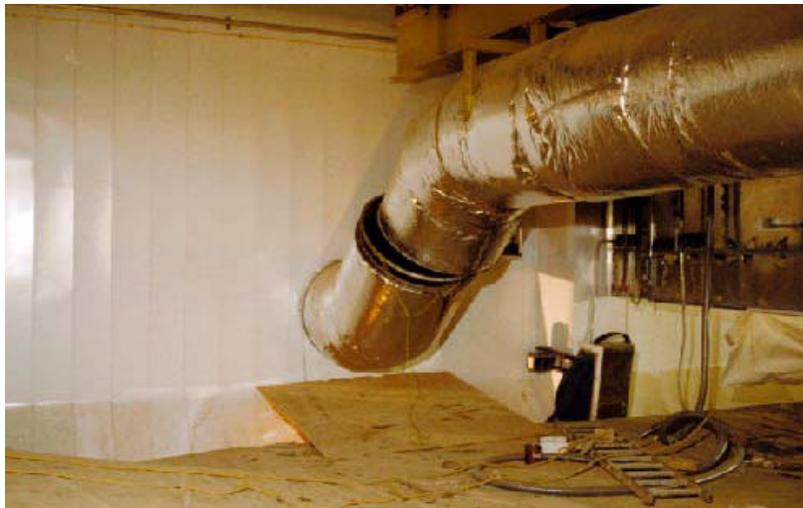
A temporary platform (see Exhibit 2-3) had been installed in the area

of the accident scene by the ductwork subcontractor, Air-Con, Inc., for use in performing work on the transition piece for the exhaust air system. The platform was made of two 3/4 inch thick plywood sheets (4 feet by 8 feet) laid side by side and fastened to 2 inch by 12 inch wooden supports with screws. The outer 18 inches of the plywood sheets extended over the wooden supports (see Exhibit 2-4). The platform was intended to facilitate bolting of the transition piece and to keep parts from falling into the gap under the

platform. It was not intended to be a work platform without 100 percent fall protection, and had no guardrails, toeboards, or other fall protection installed. The only lighting available in the area of the accident was ambient light from open rollup doors on the west side of the building. Illumination in the area of the platform was 2 foot-candles.

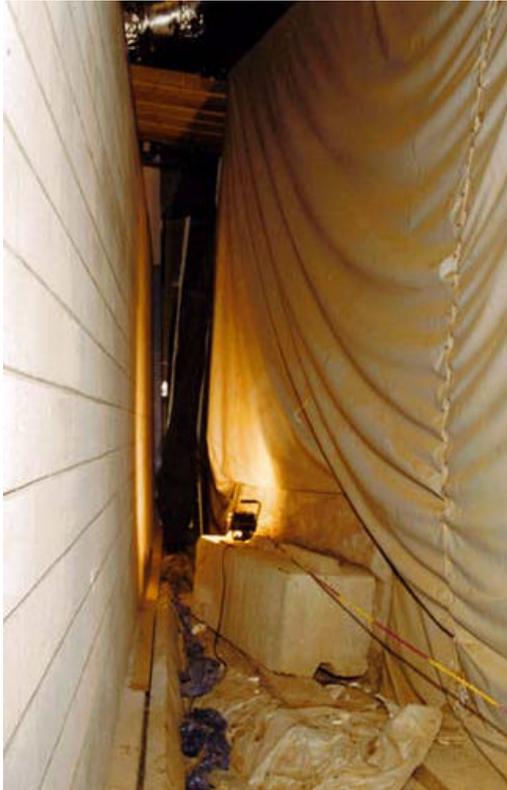
The Crane Vendor went to the edge of the stack, and, using a flashlight to look, saw the Project Engineer lying at the bottom of the gap (see Exhibit 2-5). The first lay responder arrived at the scene at 11:25 a.m. An emergency response request was made at the same time. The ambulance arrived at 11:32 a.m. and left with the Project Engineer at 11:38 a.m., arriving at the Central Facilities Area Medical Facility at 11:49 a.m. The Project Engineer was then transported by helicopter to the Eastern Idaho Regional Medical Center in Idaho Falls, Idaho, where he died at 4:10 p.m. from severe head and neck injuries.
